Thursday, July 8, 2021

RE: 101 S 12th St Unit 402 Tampa, FL 33602

HOME INSPECTION REPORT

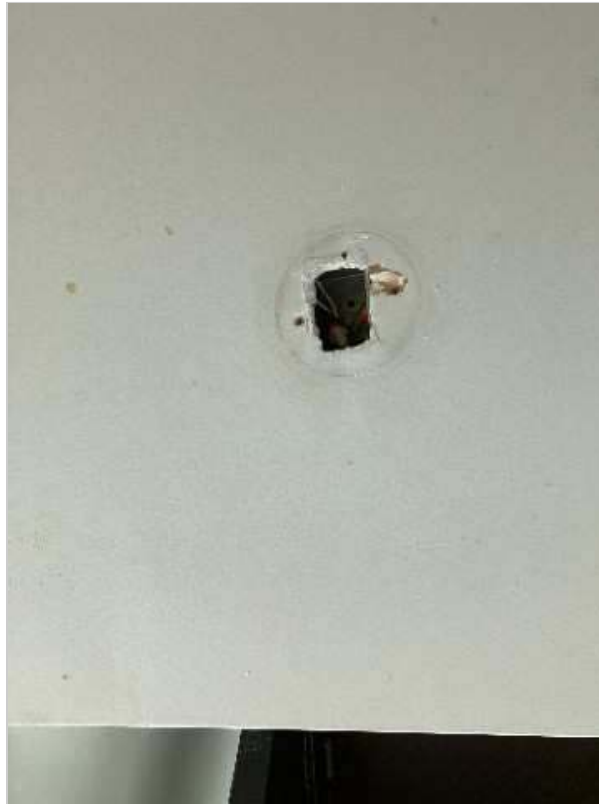
EXPOSED WIRES WERE OBSERVED IN THE FOLLOWING AREAS OF THE HOME: KITCHEN CEILING THE WIRES SHOULD BE PLACED IN CONDUITS OR JUNCTION BOXES.

Exposed wires

FURTHER EVALUATION TO DETERMINE THE EXTENT AND COST OF REPAIR SHOULD BE PERFORMED BY A QUALIFIED LICENSED ELECTRICIAN. A RECEIPT SHOULD BE LEFT FOR YOUR RECORDS AND PROTECTION.

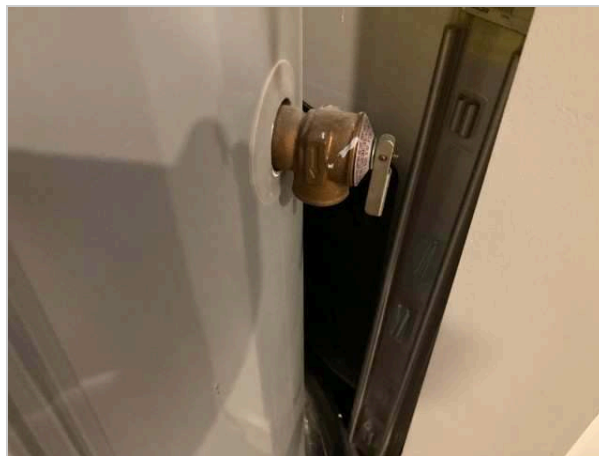
THE HOT WATER HEATER'S PRESSURE RELIEF VALVE'S DISCHARGE PIPE WAS MISSING. IT SHOULD BE A 3/4" METAL OR CPVC PIPE. THIS IS AN IMPORTANT SAFETY FEATURE.

Missing discharge pipe

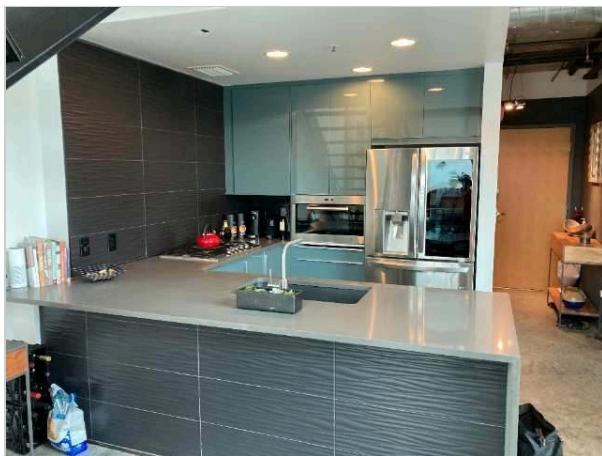
The Viking natural gas cooktop was inspected and DID NOT activate at the time of the inspection. The accuracy of the clock, timers and settings on ovens are not within the scope of this inspection.
