Thursday, July 8, 2021

RE: 101 S 12th St Unit 402 Tampa, FL 33602

HOME INSPECTION REPORT

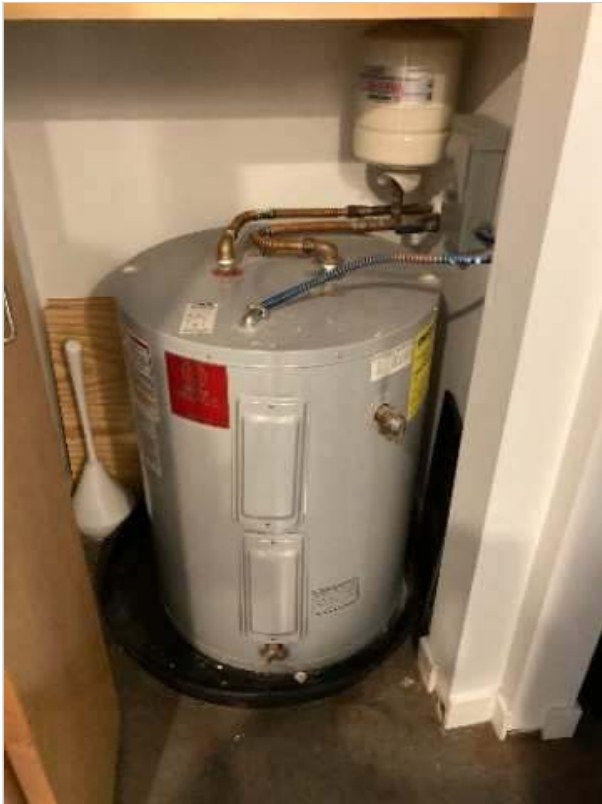
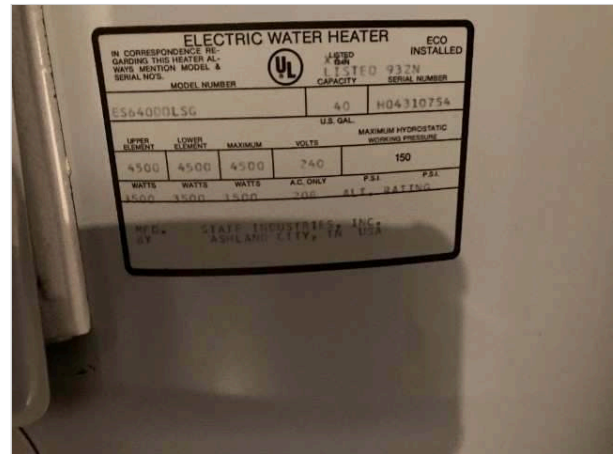
THE HOT WATER HEATER'S PRESSURE RELIEF VALVE'S DISCHARGE PIPE WAS MISSING. IT SHOULD BE A 3/4" METAL OR CPVC PIPE. THIS IS AN IMPORTANT SAFETY FEATURE.

Missing discharge pipe

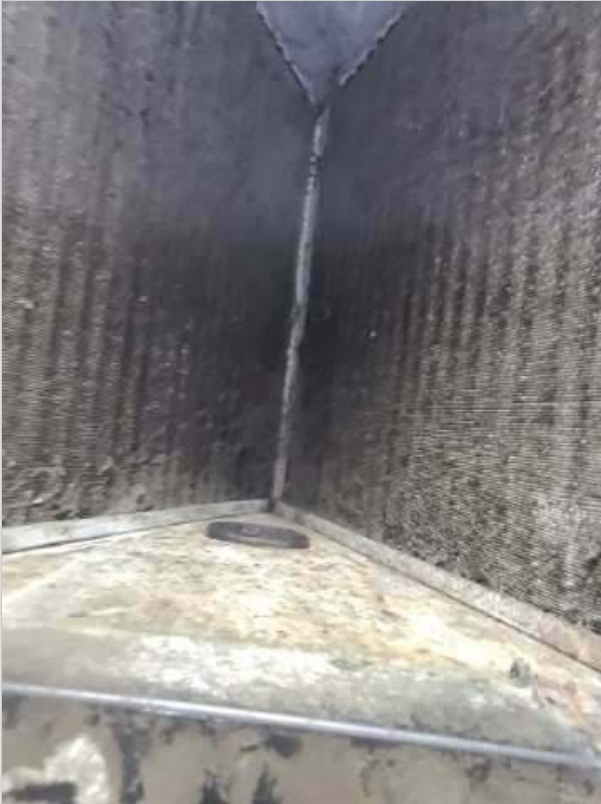
WHILE THE HVAC SYSTEM IS OPERATING WITHIN THE NORMAL PARAMETERS THERE ARE SOME ISSUES WITH THE SYSTEM THAT NEED TO BE ADDRESSED. PLEASE SEE THE HVAC REPORT FOR DETAILS.

DUE TO THE AGE OF THE HVAC SYSTEM THERE MAY BE LIMITED LIFE REMAINING.
